LA-UR-21-20833

Title: GRING18 Corrosion Characterization

GRING18 Corrosion Characterization

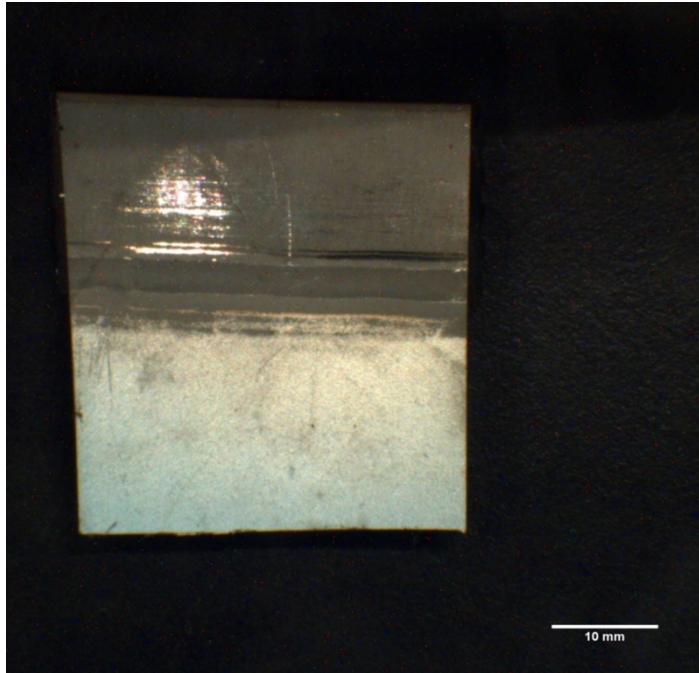
Glove-box (GB) microscope

Machined area of wall has areas that appear dull due to general corrosion. The general corrosion extends for about 1 cm below the weld.

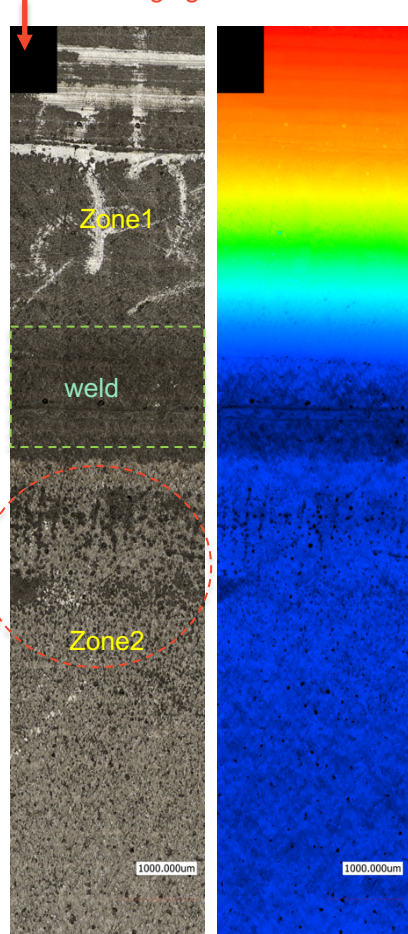
Issues with imaging

Small pits
Light surface corrosion

Corrosion appears to be different at both zones

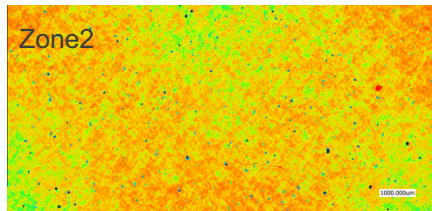
Corrosion Pits Diameter Vs Depth

- Bimodal pit distribution
- Indication that surface has a significant effect on corrosion
